INSTALLATION INSTRUCTIONS

PRO TRAXX 6 OVAL STEP BAR

2019 Chevrolet Silverado/GMC Sierra 1500 Crew Cab & Double Cab (Excl. 2019 Silverado LD/Sierra 1500 Limited)

21-64130, 21-64135 (Crew Cab) 21-64120, 21-64125 (Double Cab)

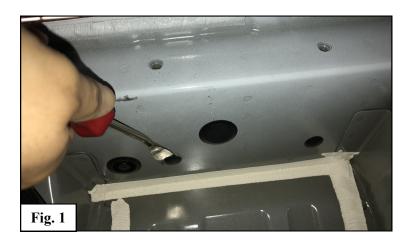
- 1. Remove contents from box, verify if all parts listed are present and free from damage. Carefully read and understand all instructions before attempting installation.
 - Failure to identify damage before installation could lead to a rejection of any claim.
- 2. Starting on the driver side, remove the rubber plugs located on the rocker panel at each mounting location. See **Figure 1**.
- 3. **For models with threaded holes:** At each bracket mounting location on the rocker panel there should be a welded factory nut.

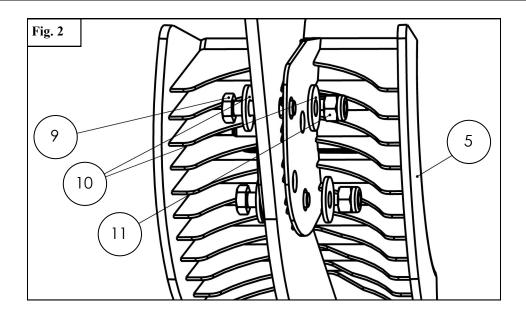
4. Secure the Plastic Bracket Covers (item 5) to the Mounting Brackets using the supplied M6 Hardware. See **Figure 2.**

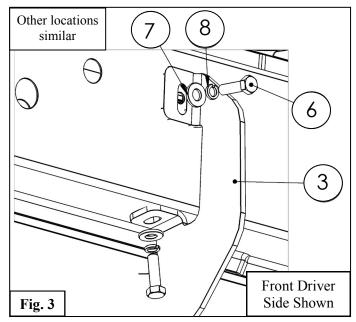
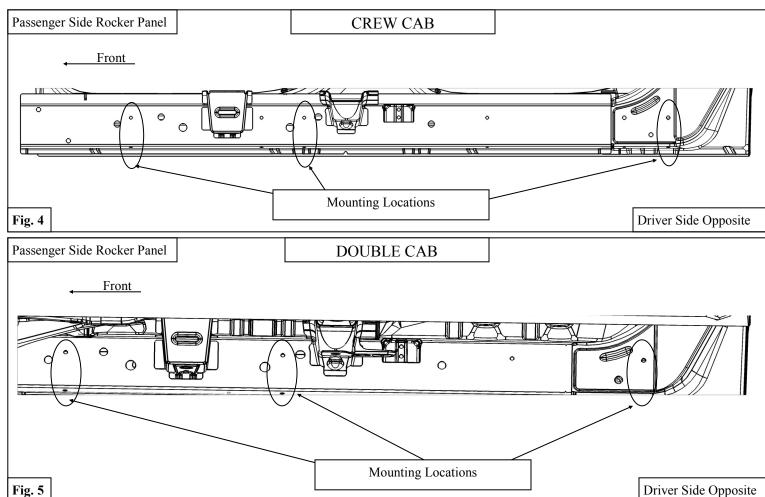
- 5. Locate (1) Mounting Bracket (Items 3,4) and loosely secure it to the rocker panel using the provided hardware: (2) M8 hex head bolt, (2) M8 flat washer, and (2) M8 lock washer. See **Figures 3, 4 and 5**.
- 6. Repeat **Step 5** for all remaining bracket mounting locations.

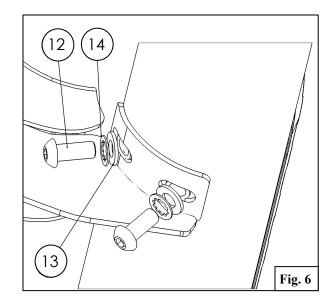
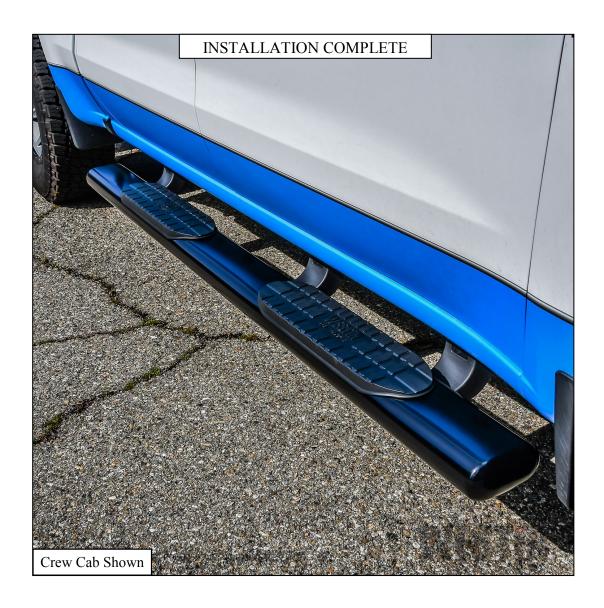
- 7. Fasten step bars respectively to either side using the M8 hardware provided with the step bars. See **Figure 6**.
- 8. Align and adjust the step bars as needed and fully tighten all hardware. Torque all M6 fasteners to 5-7 ft-lbs and all M8 fasteners to 15-18 ft-lbs.
